## Fire Hazard and Risk Assessment

### Thomastown Terminal Station Battery Energy Storage System

**Project Name:** TTS BESS

**Report Name:** Fire Hazard and Risk Assessment

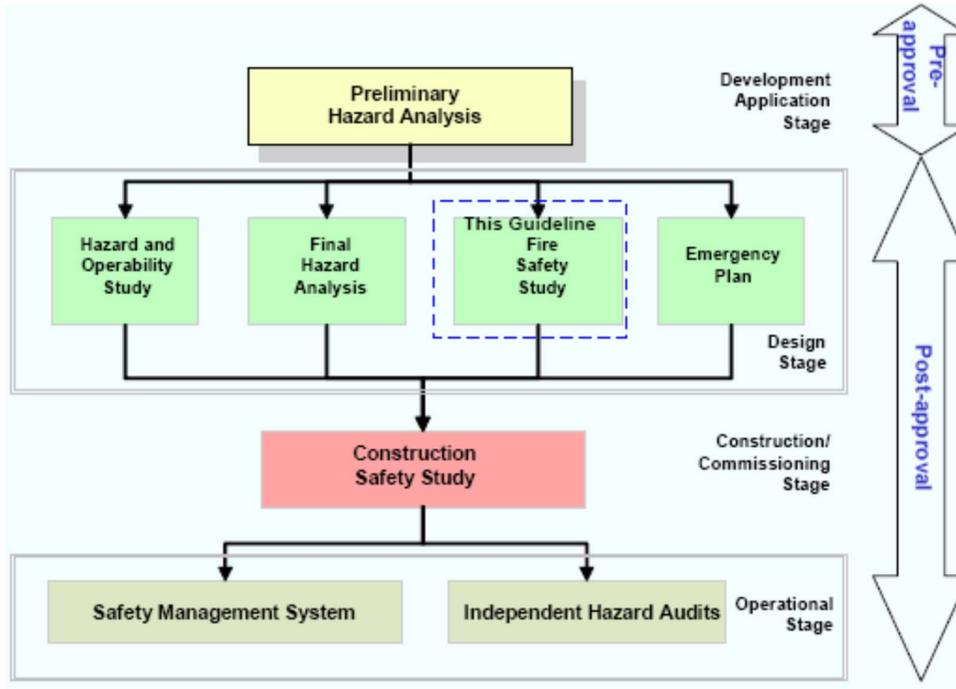
**Figure 1: The Hazards-Related Assessment Process**

This Fire Safety Assessment formulates part of an integrated assessment process for safety assurance of development proposals, which are potentially hazardous. The assessment is based on the methodology outlined in the Hazardous Industry Advisory Papers (HIPAPS). The process is shown diagrammatically in Figure 1.

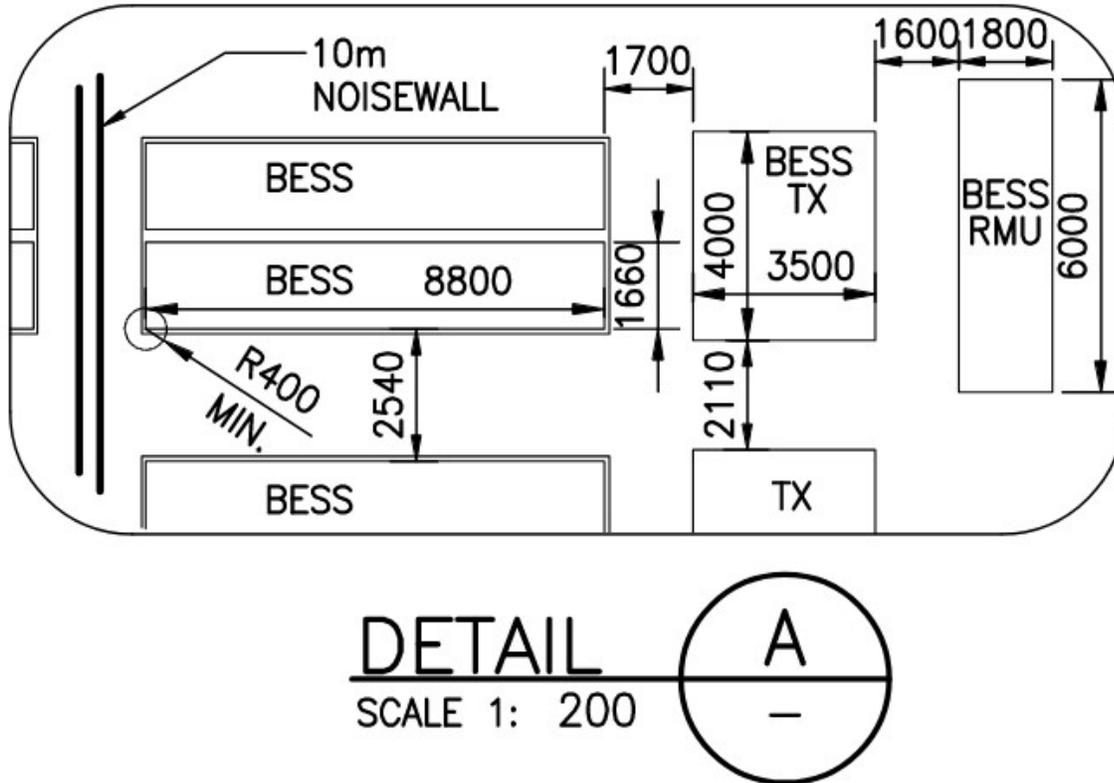
**Figure 7 BESS unit layout**

The battery units are separated into “islands” by the 6m fire brigade track and maintenance road. The units are further split into a north and south side by a 10m high noise wall.

Each battery unit is approximately 8.8m x 1.66m and located back-to-back. The set of two units are then separated from the adjacent set of two units by 2.54m and from the transformer by 1.7m. Each transformer is separated from the adjacent transformer by 2.11m.

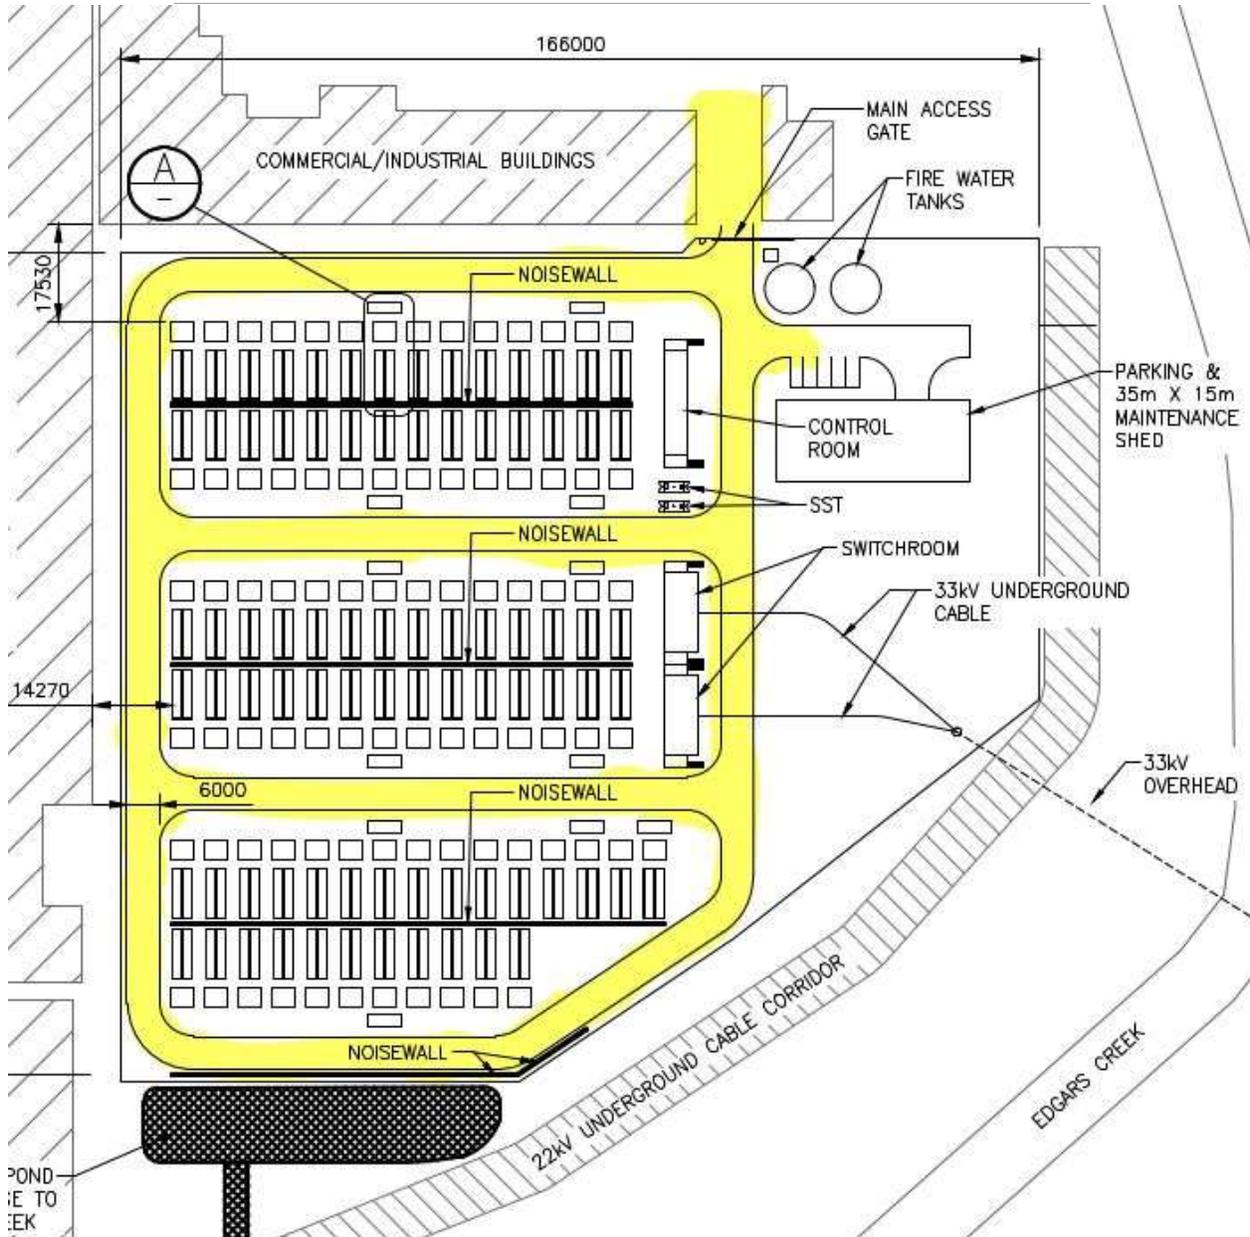
**Figure 9 Site plan showing the fire track around and through the site**

The fire tanks and booster are to be located adjacent to the access driveway that serves as the start of the fire brigade access track that is continuous around the entire facility as a 6m wide road. The 6m wide fire brigade track extends around and within the facility and separates the battery units into smaller areas. Attack fire hydrants are to be located around the fire track such that all areas can be covered by at least two hydrants.

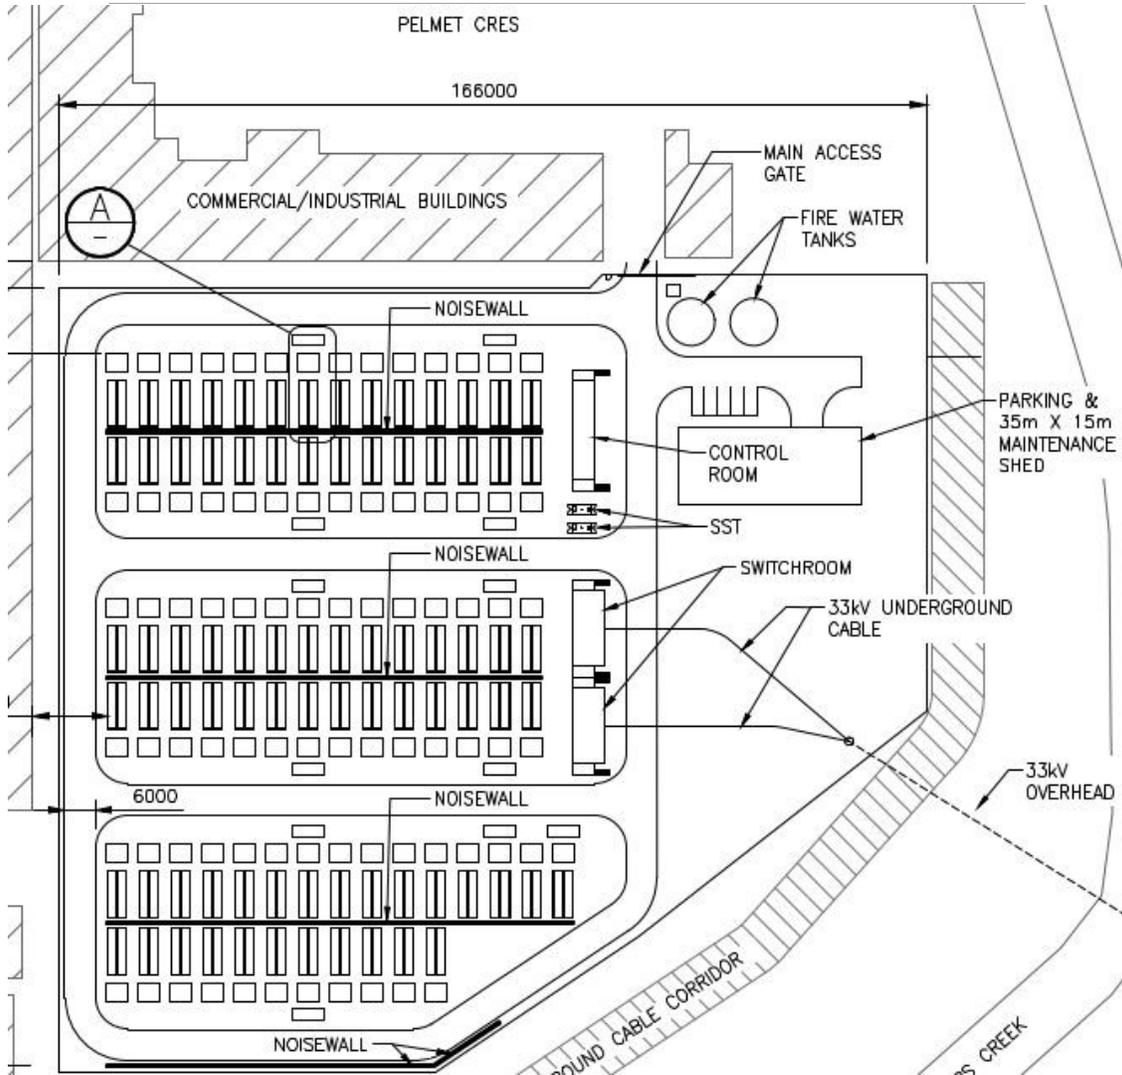
**Figure 13 Location of the battery Units to the fire booster and tanks**

The main vehicle entrance, fire tanks and booster are located approximately 25m to the East of the nearest battery unit.

The presence of the fire rated noise wall means the fire tanks and hardstand means they are protected from the main area of the facility and the level of exposure is significantly reduced.

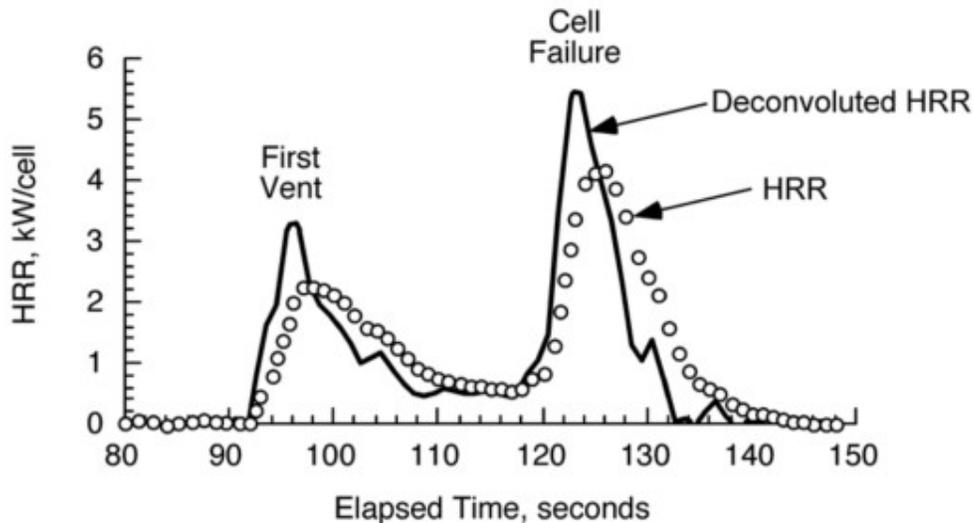
**Figure 2. Lithium-ion cell failure at 70% SOC exposed to 50 kW/m<sup>2</sup> irradiance in fire calorimeter; points are data from standard method; solid line is data corrected for instrument response**

**Figure 15 Results of a single group of batteries**

The results indicated the heat release rate per battery cell was approximately 5kW.

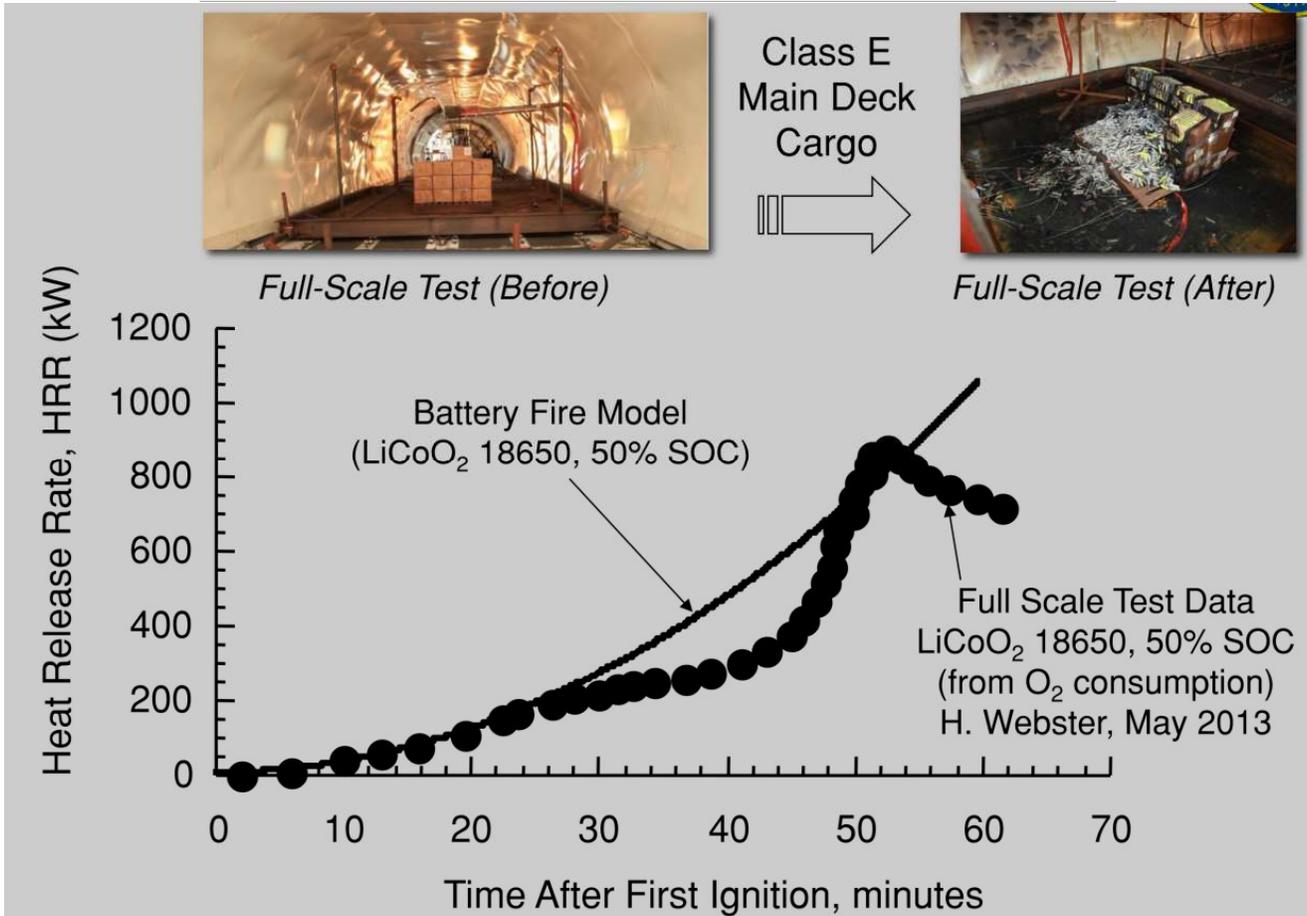
**Figure 16** Results of full-scale tests on 18650 batteries

The peak heat release rate is approximately 1MW.

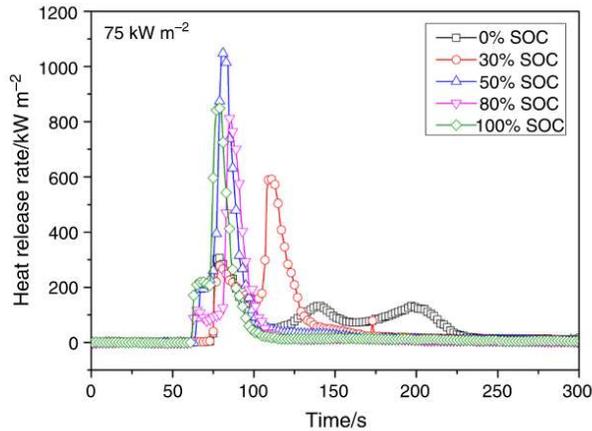
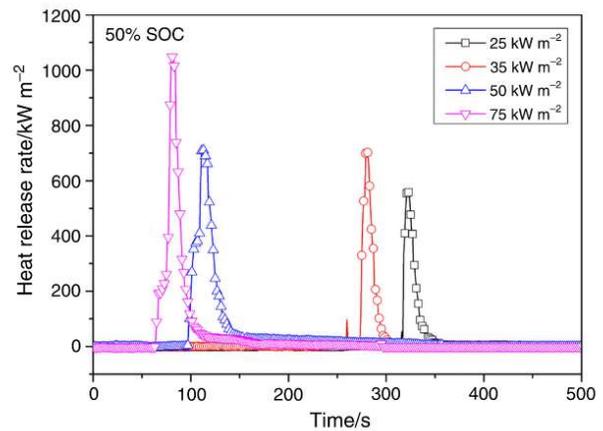
**Fig. 7** Heat release rate of batteries at different SOC's under an incident heat flux of 75 kW m<sup>-2</sup>

**Fig. 8** Heat release rate of batteries with 50% SOC under different incident heat fluxes

### **Figure 17 Tested heat release rates for Lithium-ion batteries**

It was reported in “Fire behaviour of lithium-ion battery with different states of charge induced by high incident heat fluxes”, by Zhi Wang that the peak heat release rate of a battery unit is approximately 700kW/m<sup>2</sup> to 1050kW/m<sup>2</sup> and an average of approximately 150 – 200kW/m<sup>2</sup>.

Note these are individual small batteries and not part of a BESS unit and the area is the surface area of the batteries. Based on the size of the units in the VBB fire as reported by the ESV investigation 7.5m x 1.6m x 2.5m) and assuming the front and the top of the unit (are burning based on the location of the ventilation the heat release rate is predicted to be 4.5MW to 6MW.

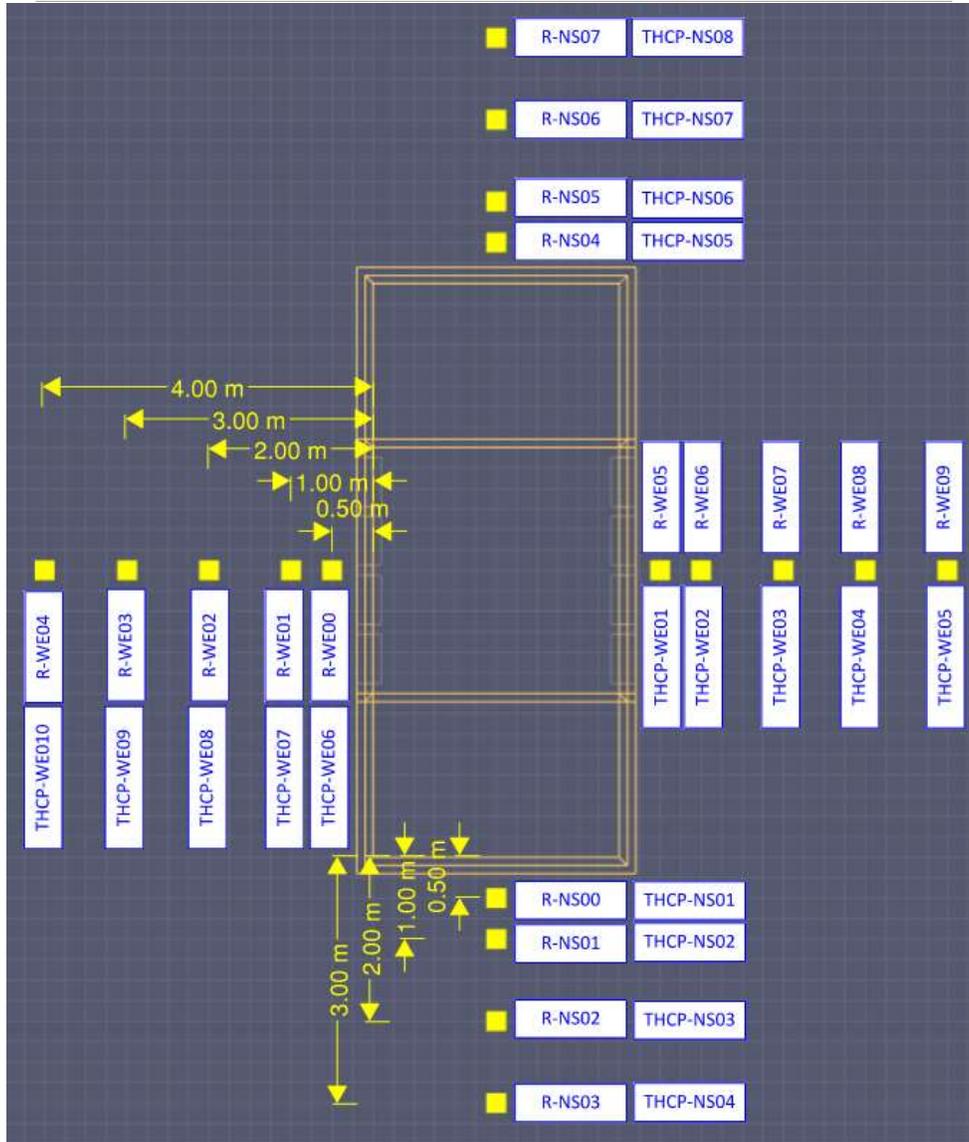
Figure 18: Model set up

Thermocouples were located at various heights and distances from the unit.

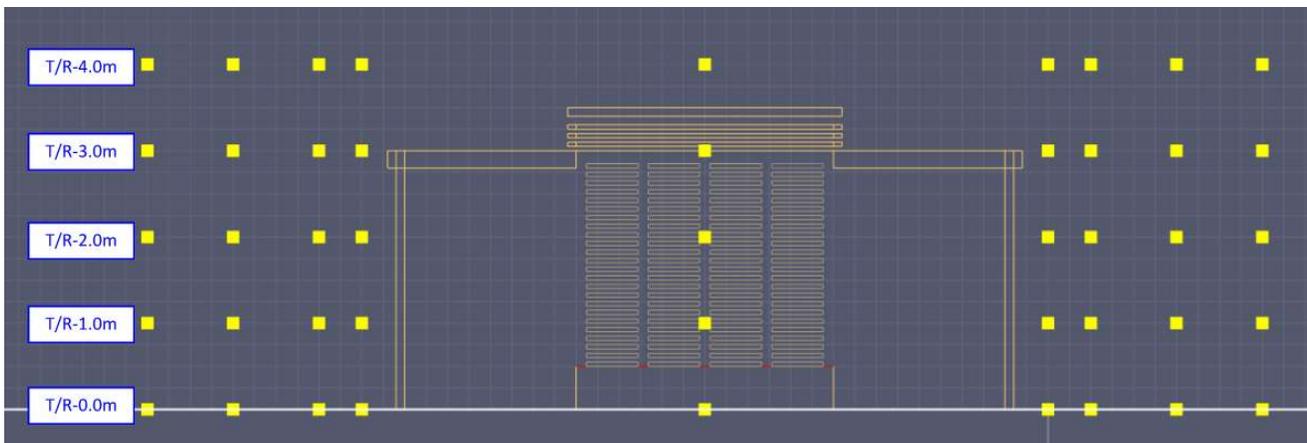
Figure 19 Model set up. Elevation View

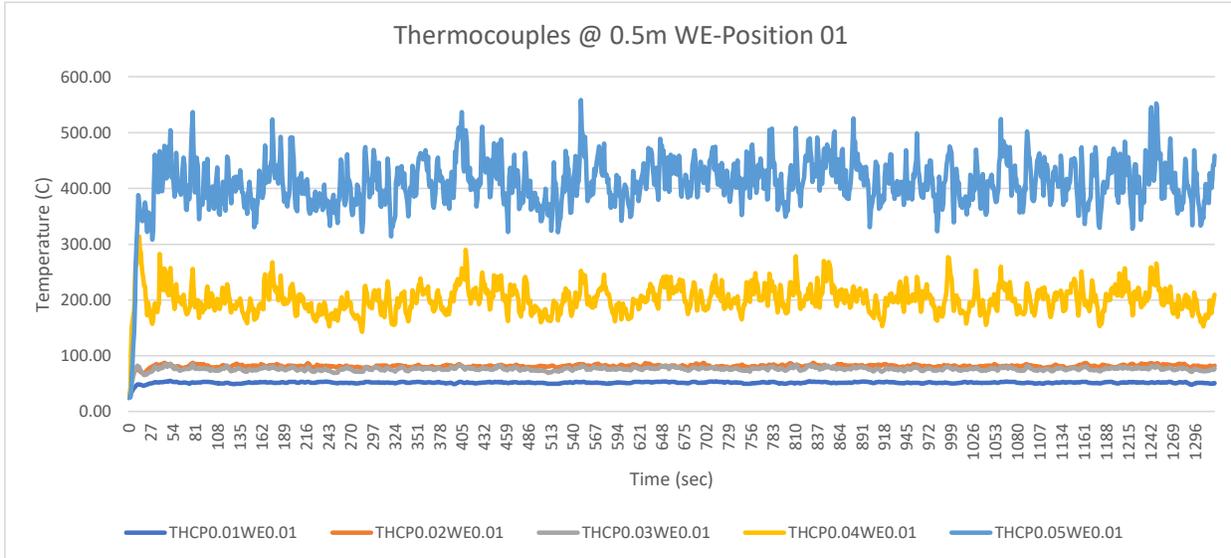
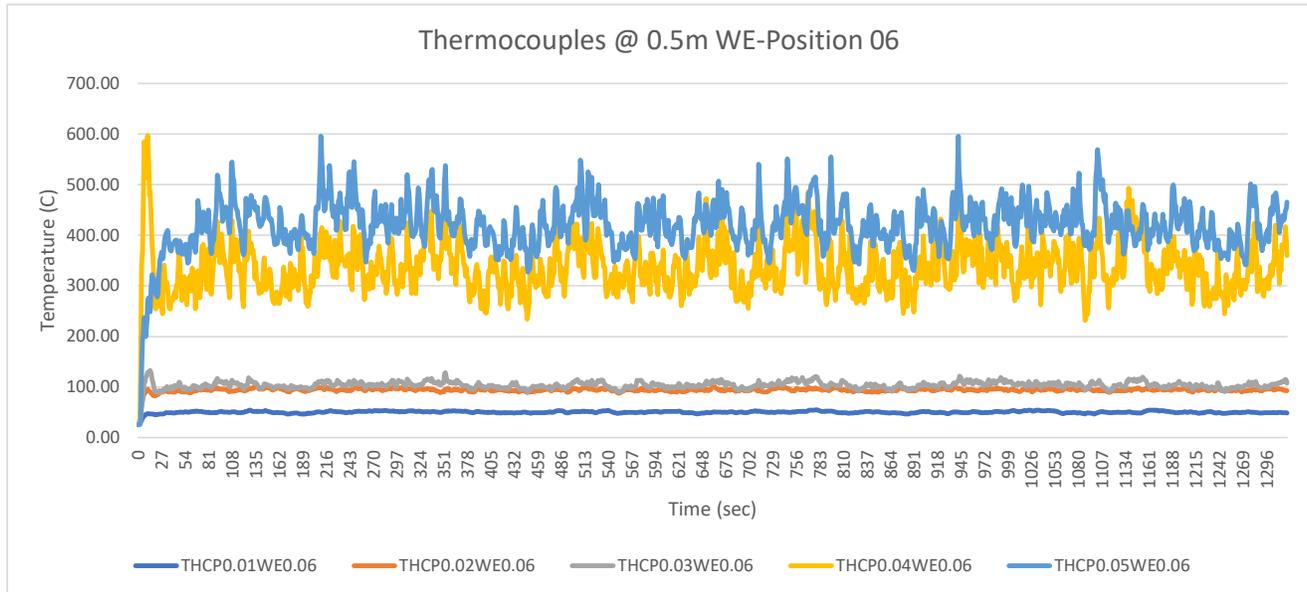
**Figure 20 maximum temperatures for no wind case**

For the no wind case temperature peaks above 550°C are reached above 4m high only to the West and East sides of the model within 0.5m from the unit. This corresponds to the area immediately opposite and above the assumed roof level vents such that the thermocouples were in the vented plume.

Heat flux of approximately 10 kW/m<sup>2</sup> are reached within 2m opposite the vents.

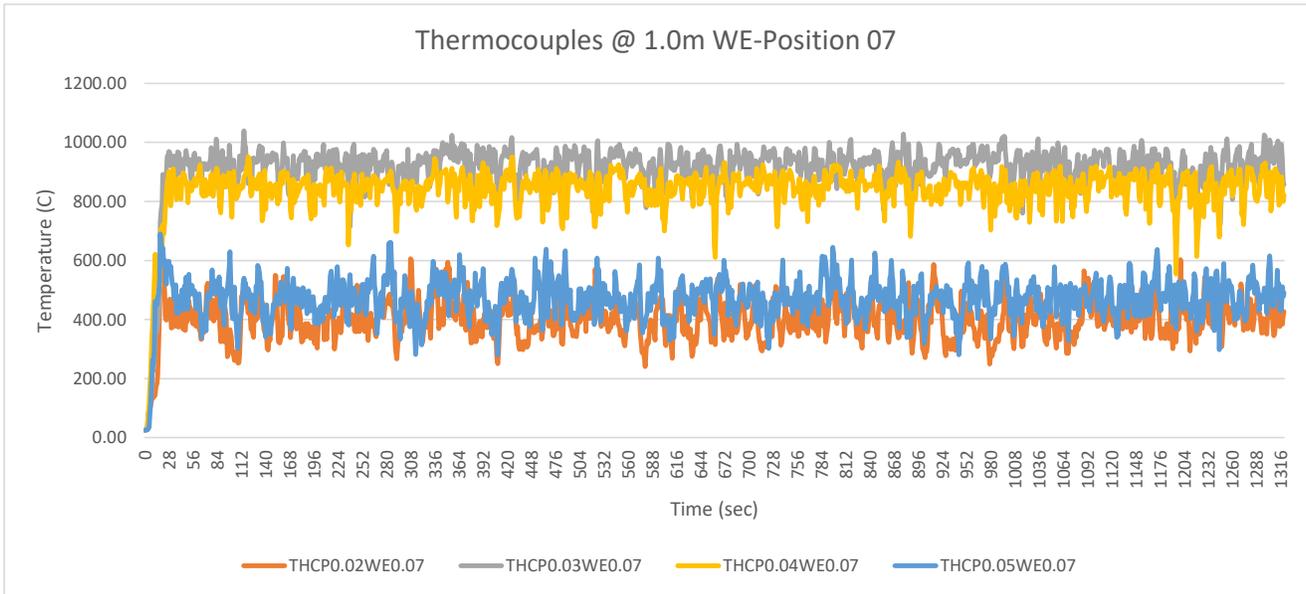
**Figure 23** Temperatures with south wind, i.e., along the unit

Temperature peaks above 550°C are reached between 1.0m and 4.0m high to the west side of the model within 1.0m from the unit.

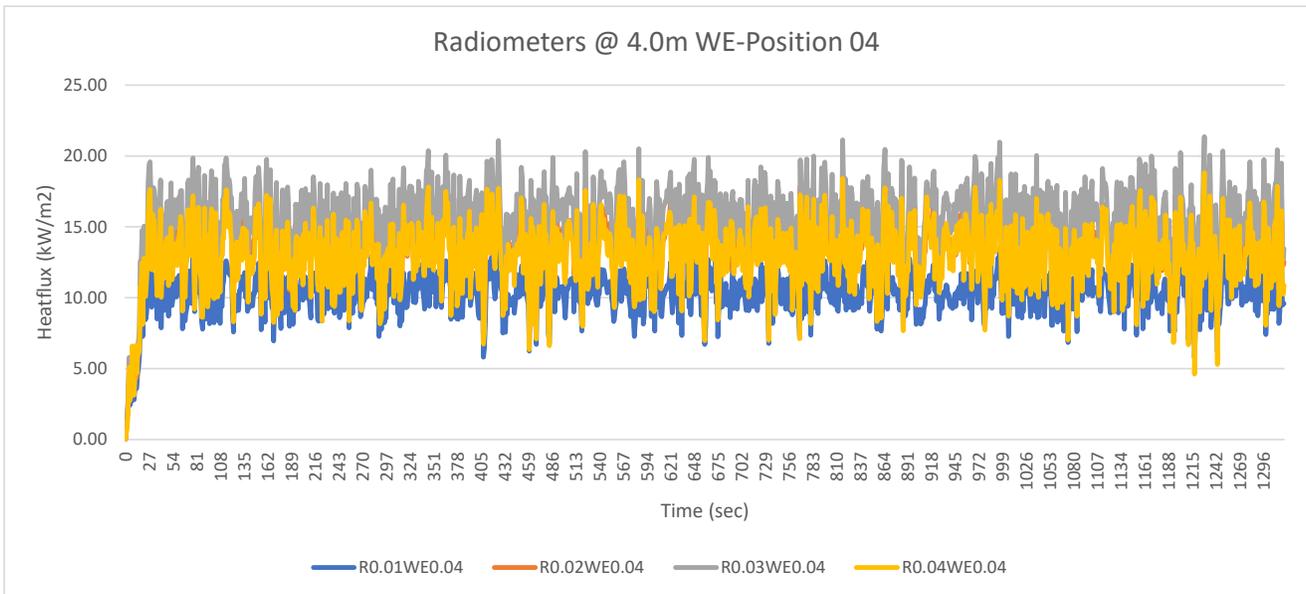
**Figure 24** Radiation with south wind, i.e., along the unit

Heat flux above 12.5 kW/m<sup>2</sup> are reached within 4m from the unit, between 0m and 4m high to the west side. After 3m high or at greater distances the heat flux decreases significantly.

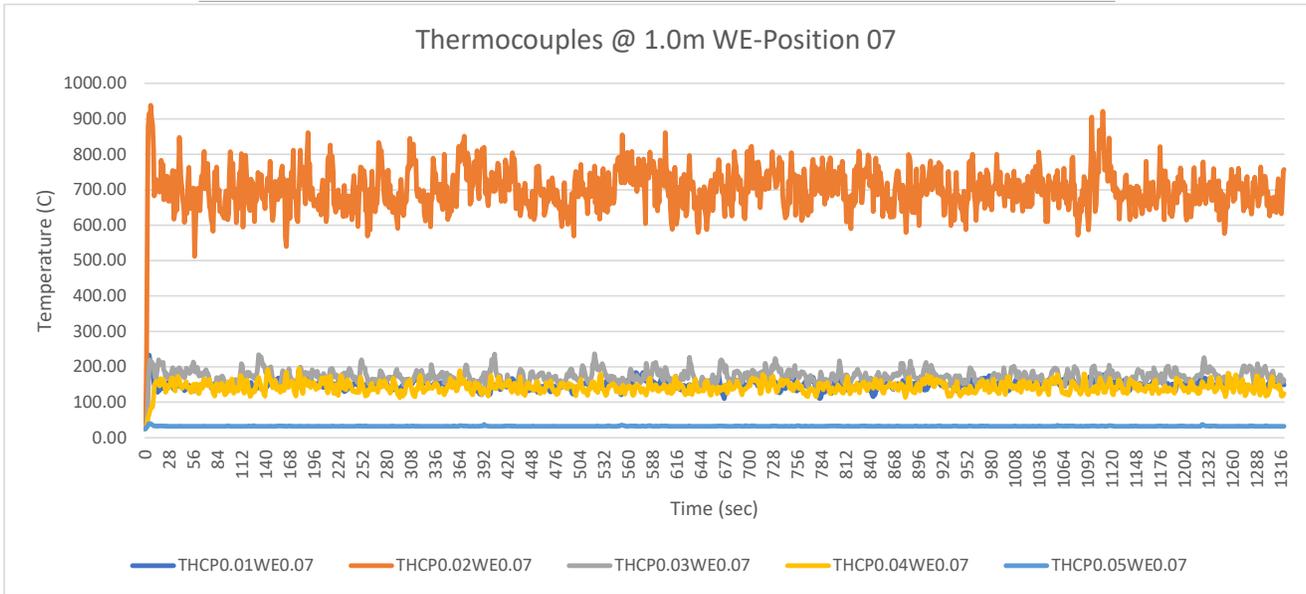
**Figure 25 Temperatures within 1m of the side of the unit**

Temperature peaks above 550°C are reached at 1m high only to the west side of the model within 1.0m from the unit.

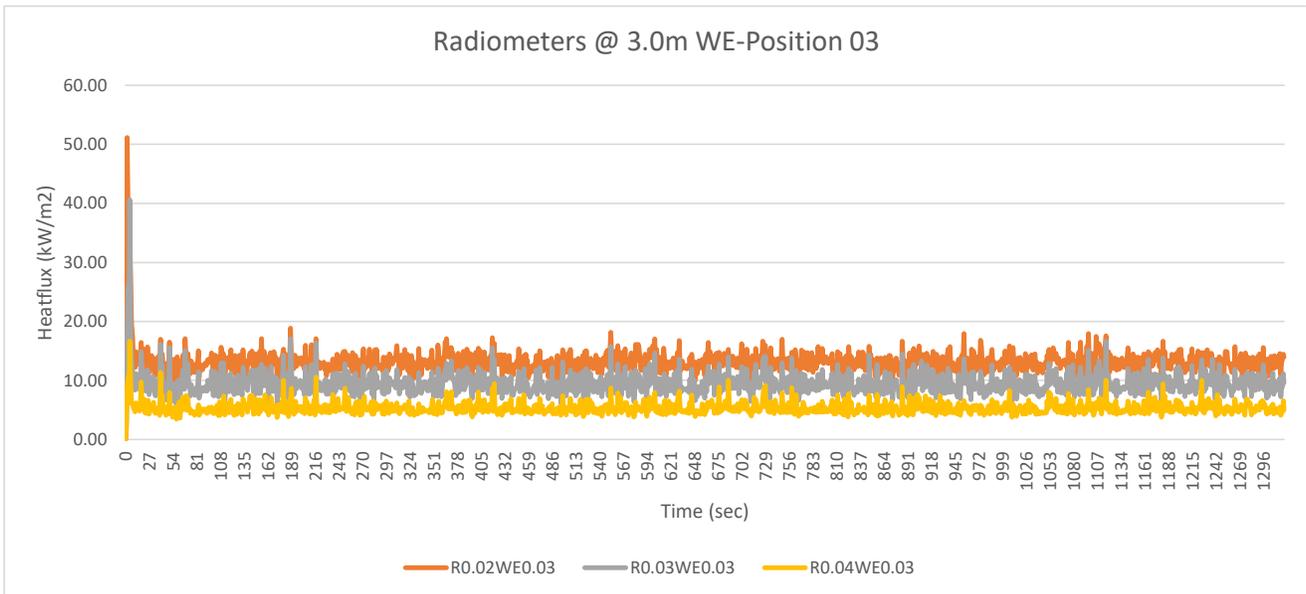
**Figure 26 Heat flux**

Heat flux above 12.5 kW/m<sup>2</sup> are reached within 3m from the unit, between 0m and 2m high to the west side. After 2m high the heat flux decreases.

It is expected the same result on the opposite side if the wind flows in the opposite direction.

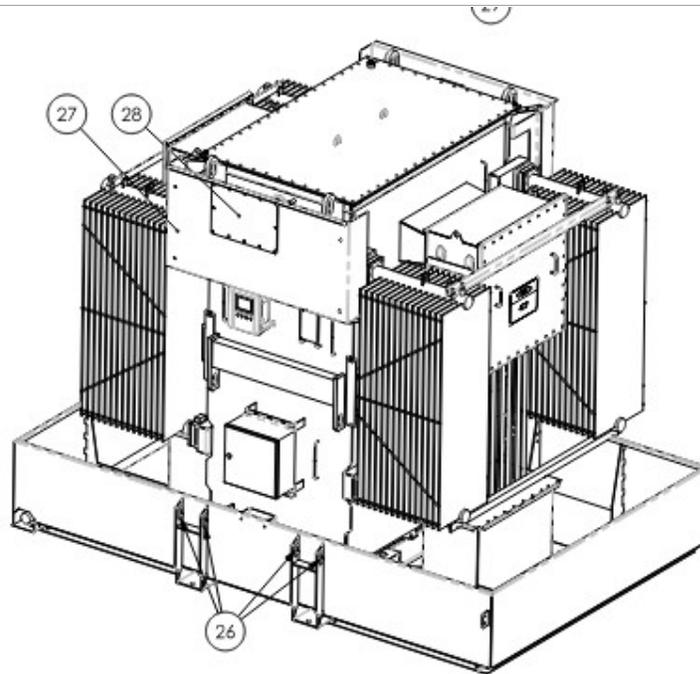
**Figure 28 Transformer showing bund at the base**

A transformer is located at the end of each set of batteries. The transformers have a galvanised steel bund at the base of the skid. The bunds have a capacity of 392L

The bunds are approximately 3.7m long and 2.8m wide, i.e., 10.4m<sup>2</sup>.

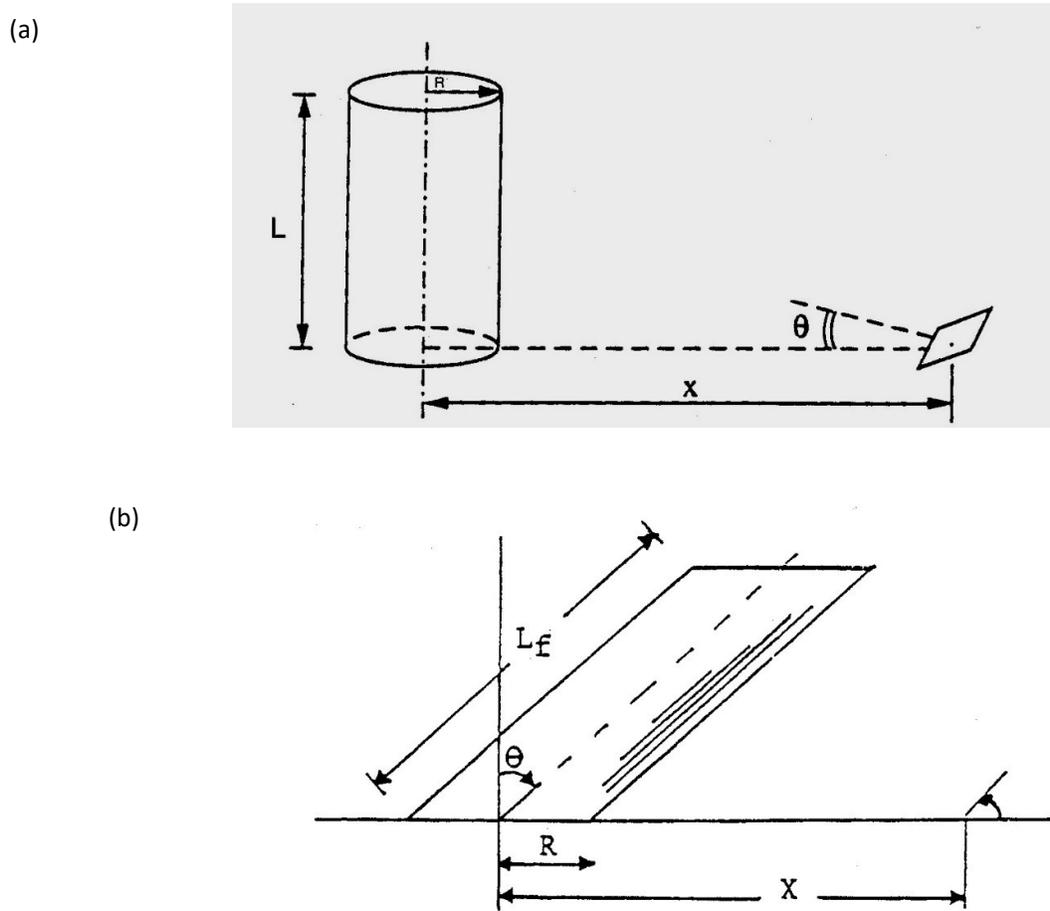
**Figure 29: (a) Target and flame geometry of vertical cylindrical radiator. (b) Target and flame geometry of tilted cylindrical radiator**

For the former conditions, the geometry of the pool fire is best approximated as an upright cylinder while for the latter conditions, a tilted cylinder geometry is best (Figure 29).

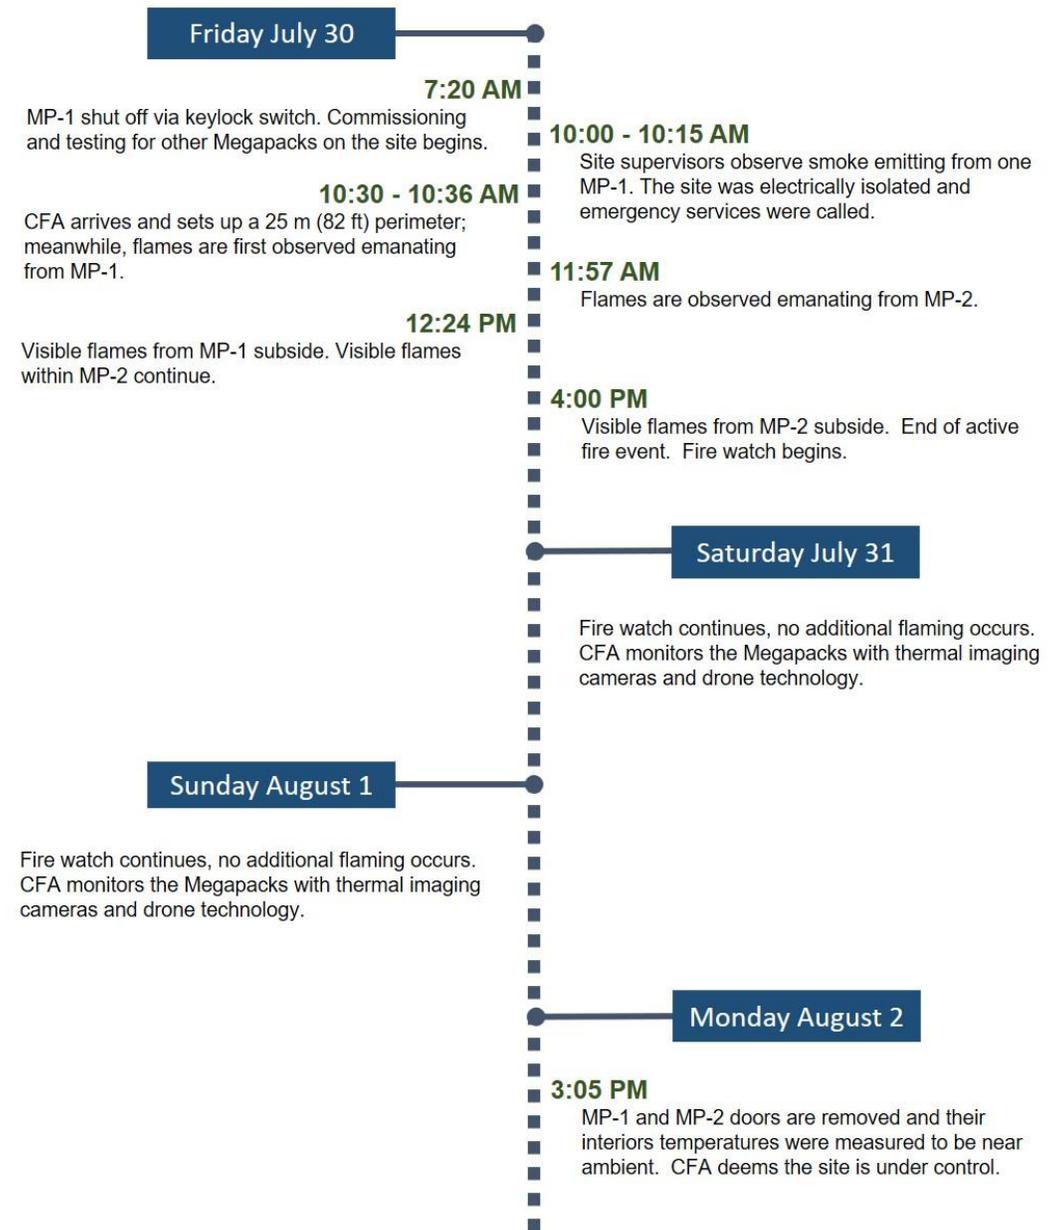
# Incident Timeline

Note: The time stamp is AEST (UTC+10) which is 19 hours ahead of USA PDT (UTC-7)

electrically isolated all the Megapacks on-site and called emergency services: Country Fire Authority (CFA). The CFA arrived shortly thereafter and set up a 25 m (82 ft) perimeter around MP-1. They also began applying cooling water to nearby exposures as recommended in Tesla’s ERG. The fire eventually spread into a neighbor Megapack (MP-2) installed 15 centimeters (cm), or 6 inches (in), behind MP-1. The CFA permitted MP-1 and MP-2 to burn themselves out and did not directly apply water into or onto either Megapack, as recommended in Tesla’s ERG. By 4:00 PM (approximately six hours after the start of the event), visible fire had subdued and a fire watch was instituted. The CFA monitored the site for the next three days before deeming it under control on August 2, 2021, at which time, the CFA handed the site over for the fire investigation to begin.

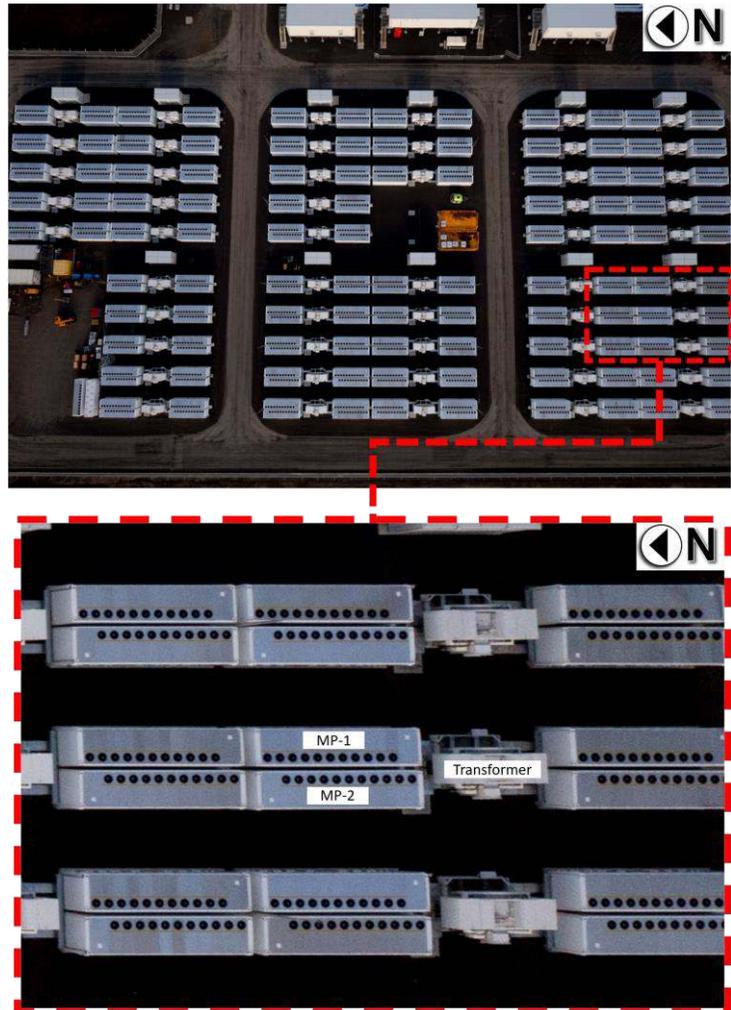
Figure 1 VBB Megapack layout (top) and area of fire origin (bottom)

The VBB fire investigation process involved analyzing not only the root cause of the initial fire in MP-1 but also the root cause of the fire propagation into MP-2. The Megapack has been designed to be installed in close proximity to each other without fire propagating to adjacent units. The design objective of the Megapack in terms of limiting fire propagation was mainly reliant on the thermal insulation of the Megapack's exterior vertical steel panels and the sheer mass of the battery modules acting as a heat sink (i.e., they are difficult to heat up). With this thermal insulation, the Megapack spacing can be as close as 15 cm (6 in) to the sides and back of each unit with 2.4 m (8 ft) aisles in front of each Megapack, as shown in Figure 1. This product spacing has been validated in UL9540A unit level tests.<sup>8</sup> Similar to the fire origin and cause investigation, the on-site inspections were supported simultaneously with an analysis of telemetry data (such as internal temperatures) from MP-2 and fire testing. The on-site investigation findings, the telemetry data analysis and fire tests, when combined, identified a scenario where Megapack to Megapack fire propagation can occur.

Flames exiting the roof of MP-1 were significantly impacted by the wind conditions at the time of the fire. Wind speeds were recorded between 20-30 knots<sup>9</sup> which pushed the flames exiting the roof of MP-1 towards the roof of MP-2. This direct flame impingement on the top of the thermal roof of MP-2 ignited the internal components of MP-2, most notably, the plastic overpressure vents that seal the battery bay<sup>10</sup> from the thermal roof. Once ignited, the overpressure vents provided a direct path for flames and hot gases to enter into the battery bays, thus exposing the battery modules of MP-2 to fire and/or elevated temperatures. Exposed to temperatures above their thermal runaway threshold of 139°C (282°F), the cells within the battery modules eventually failed and became involved in the fire.

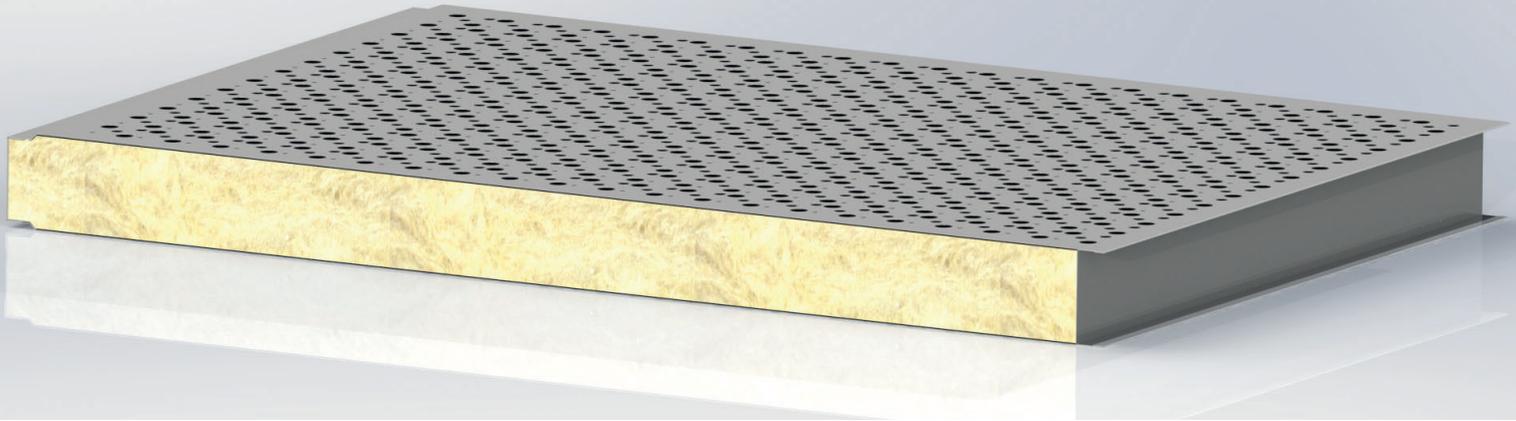
Self-supporting sandwich panel for sound control in industrial environments, with internally perforated steel sheet for sound absorption and solid external steel sheet for noise reduction. The large perforated surface together with the steel sheet reinforcement ensure high performance.

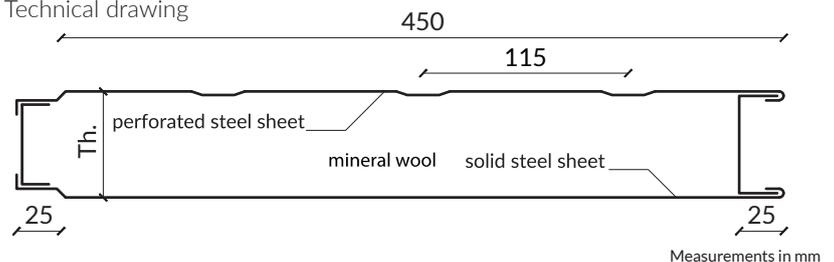
Technical drawing

Perforation CS - 38% perforated surface
